# Pre-Post Satellite Images showing damaged buildings -Dharali Village, Uttarkashi District, Uttarakhand, India.

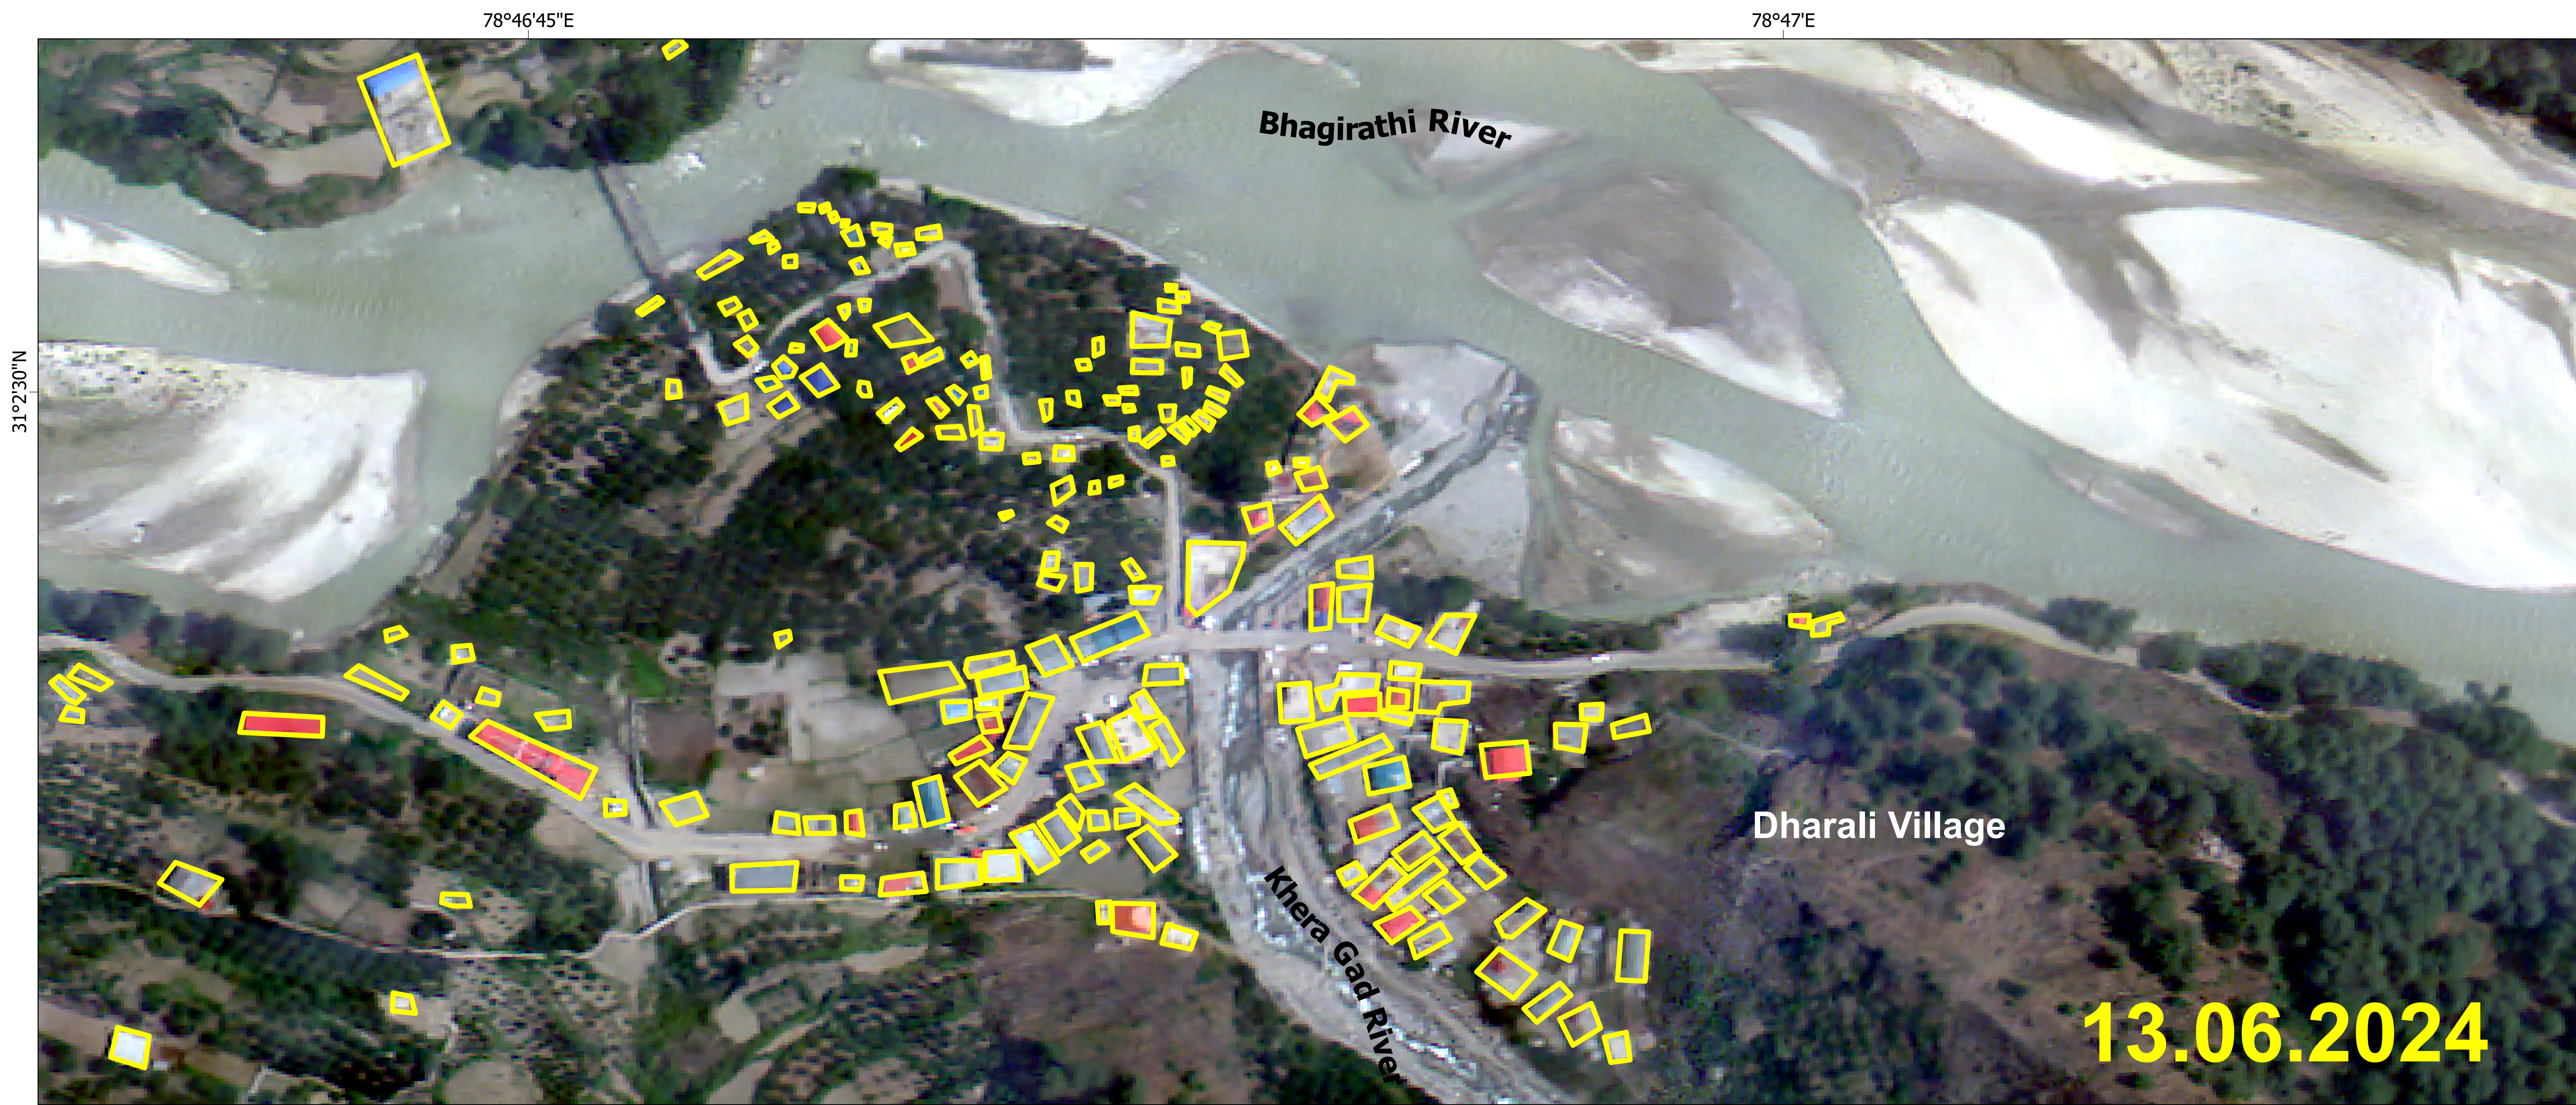
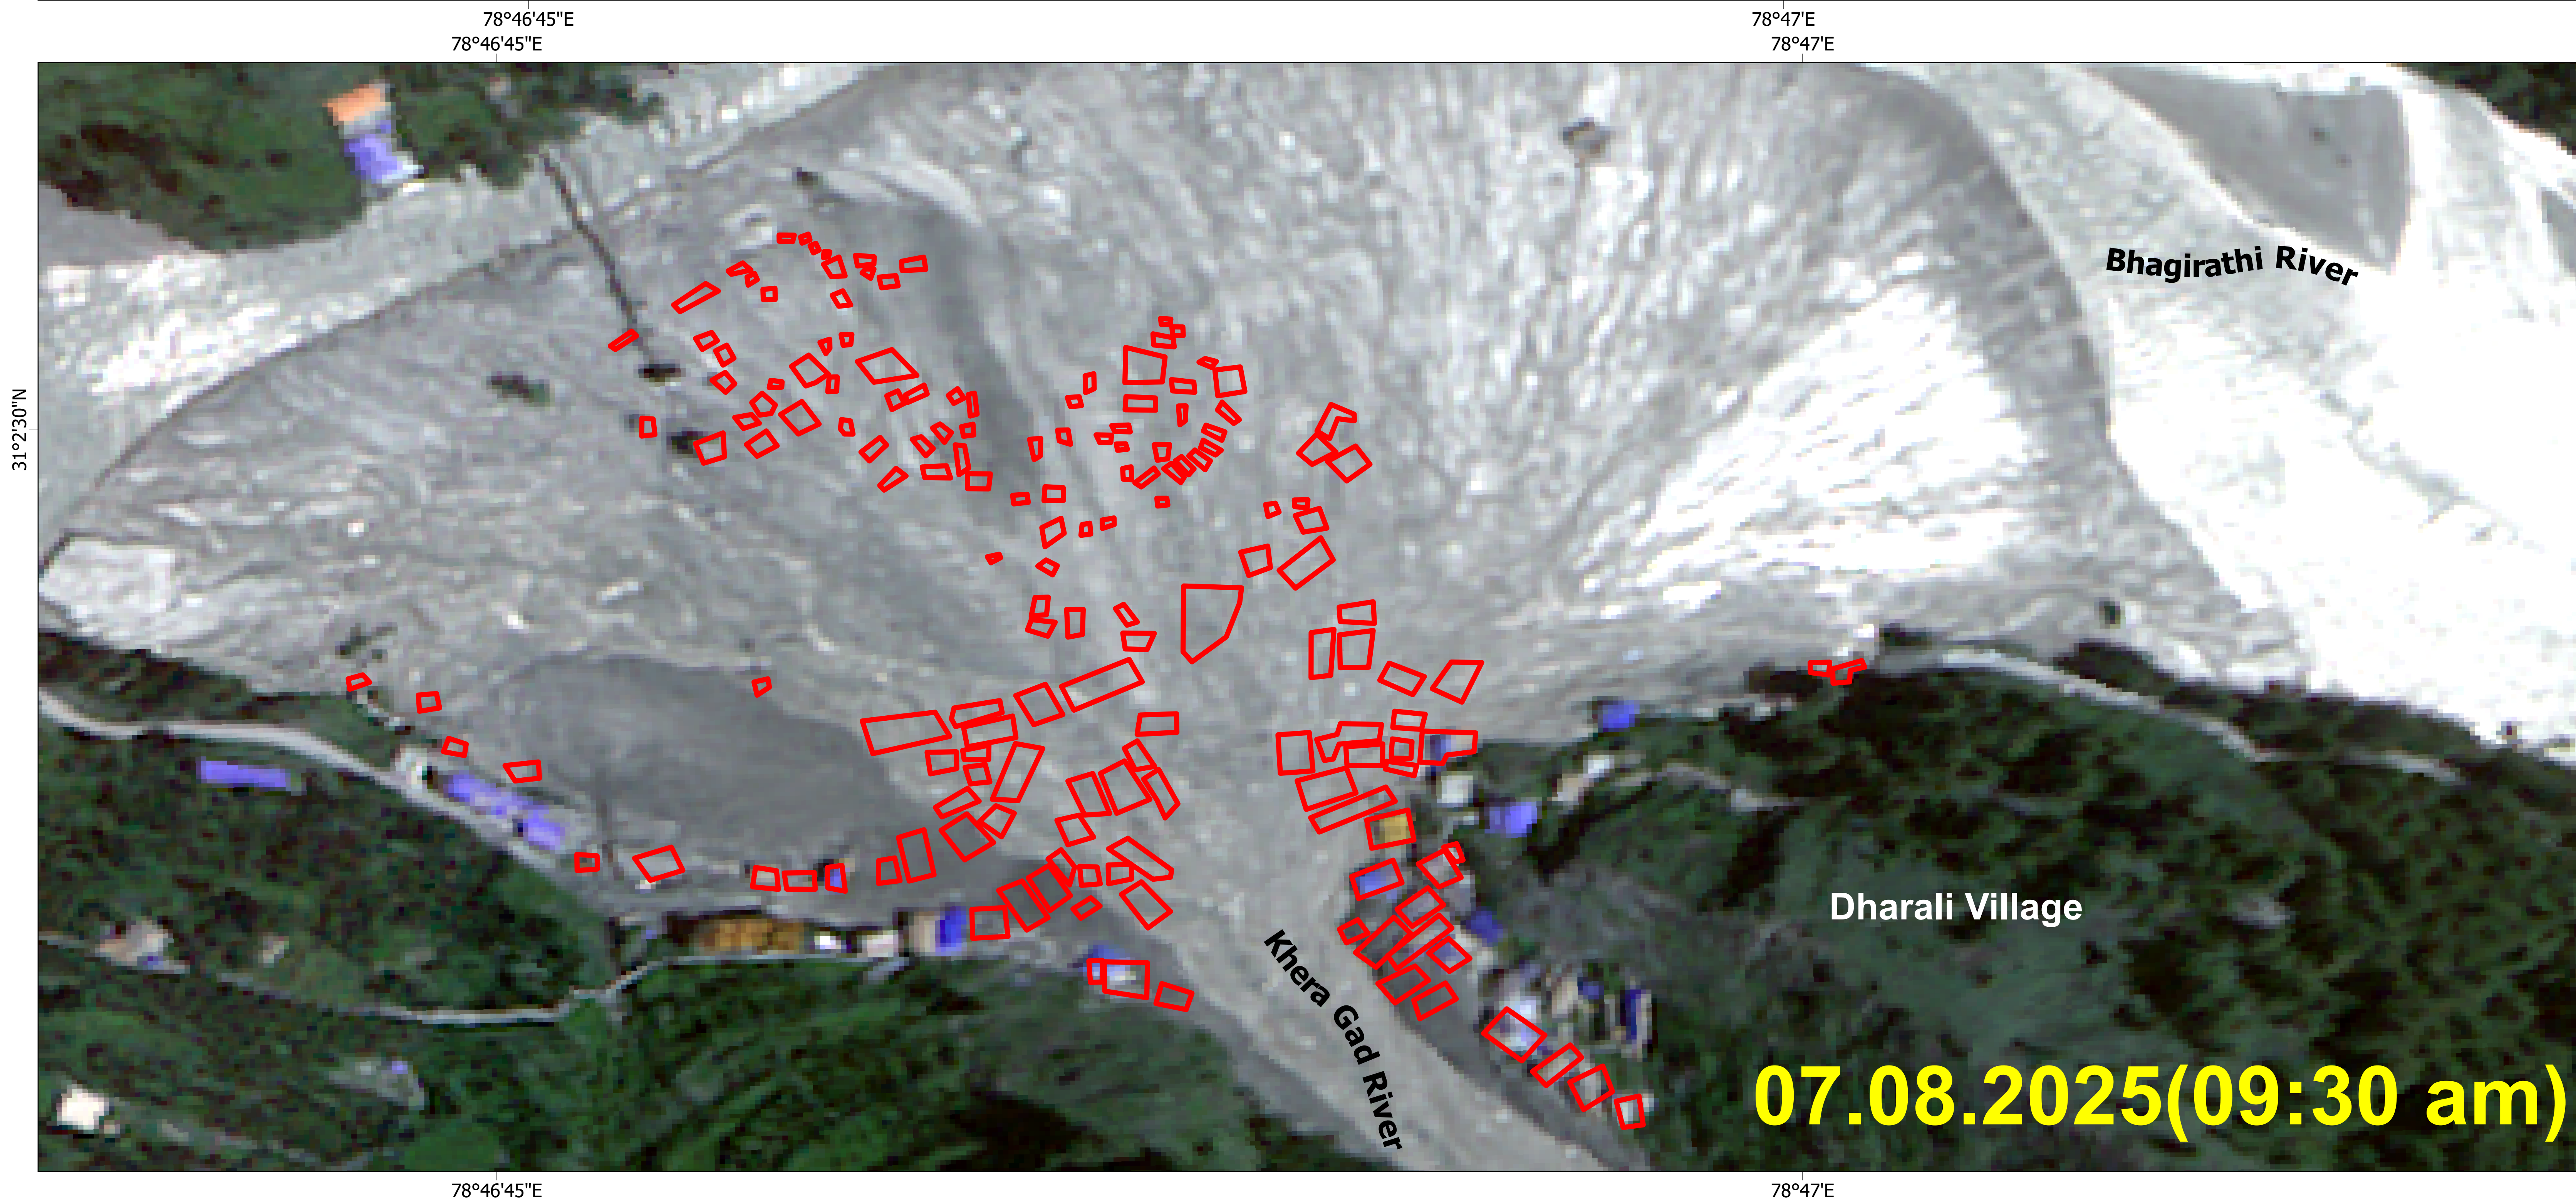
Satellite image acquired on 7th August, 2025 after the flood event. The impact is seen in Dharali village and surroundings depicting the disappearance of buildings, roads, plantations. Buildings Affected by flood are highlighted.

Pre Event Image : Cartosat-3, 13th June 2024  
Post Event : Cartosat, 07th August 2025
