Pre-Post Satellite Images showing damaged buildings -Harsil Village, Uttarkashi District, Uttarakhand, India.

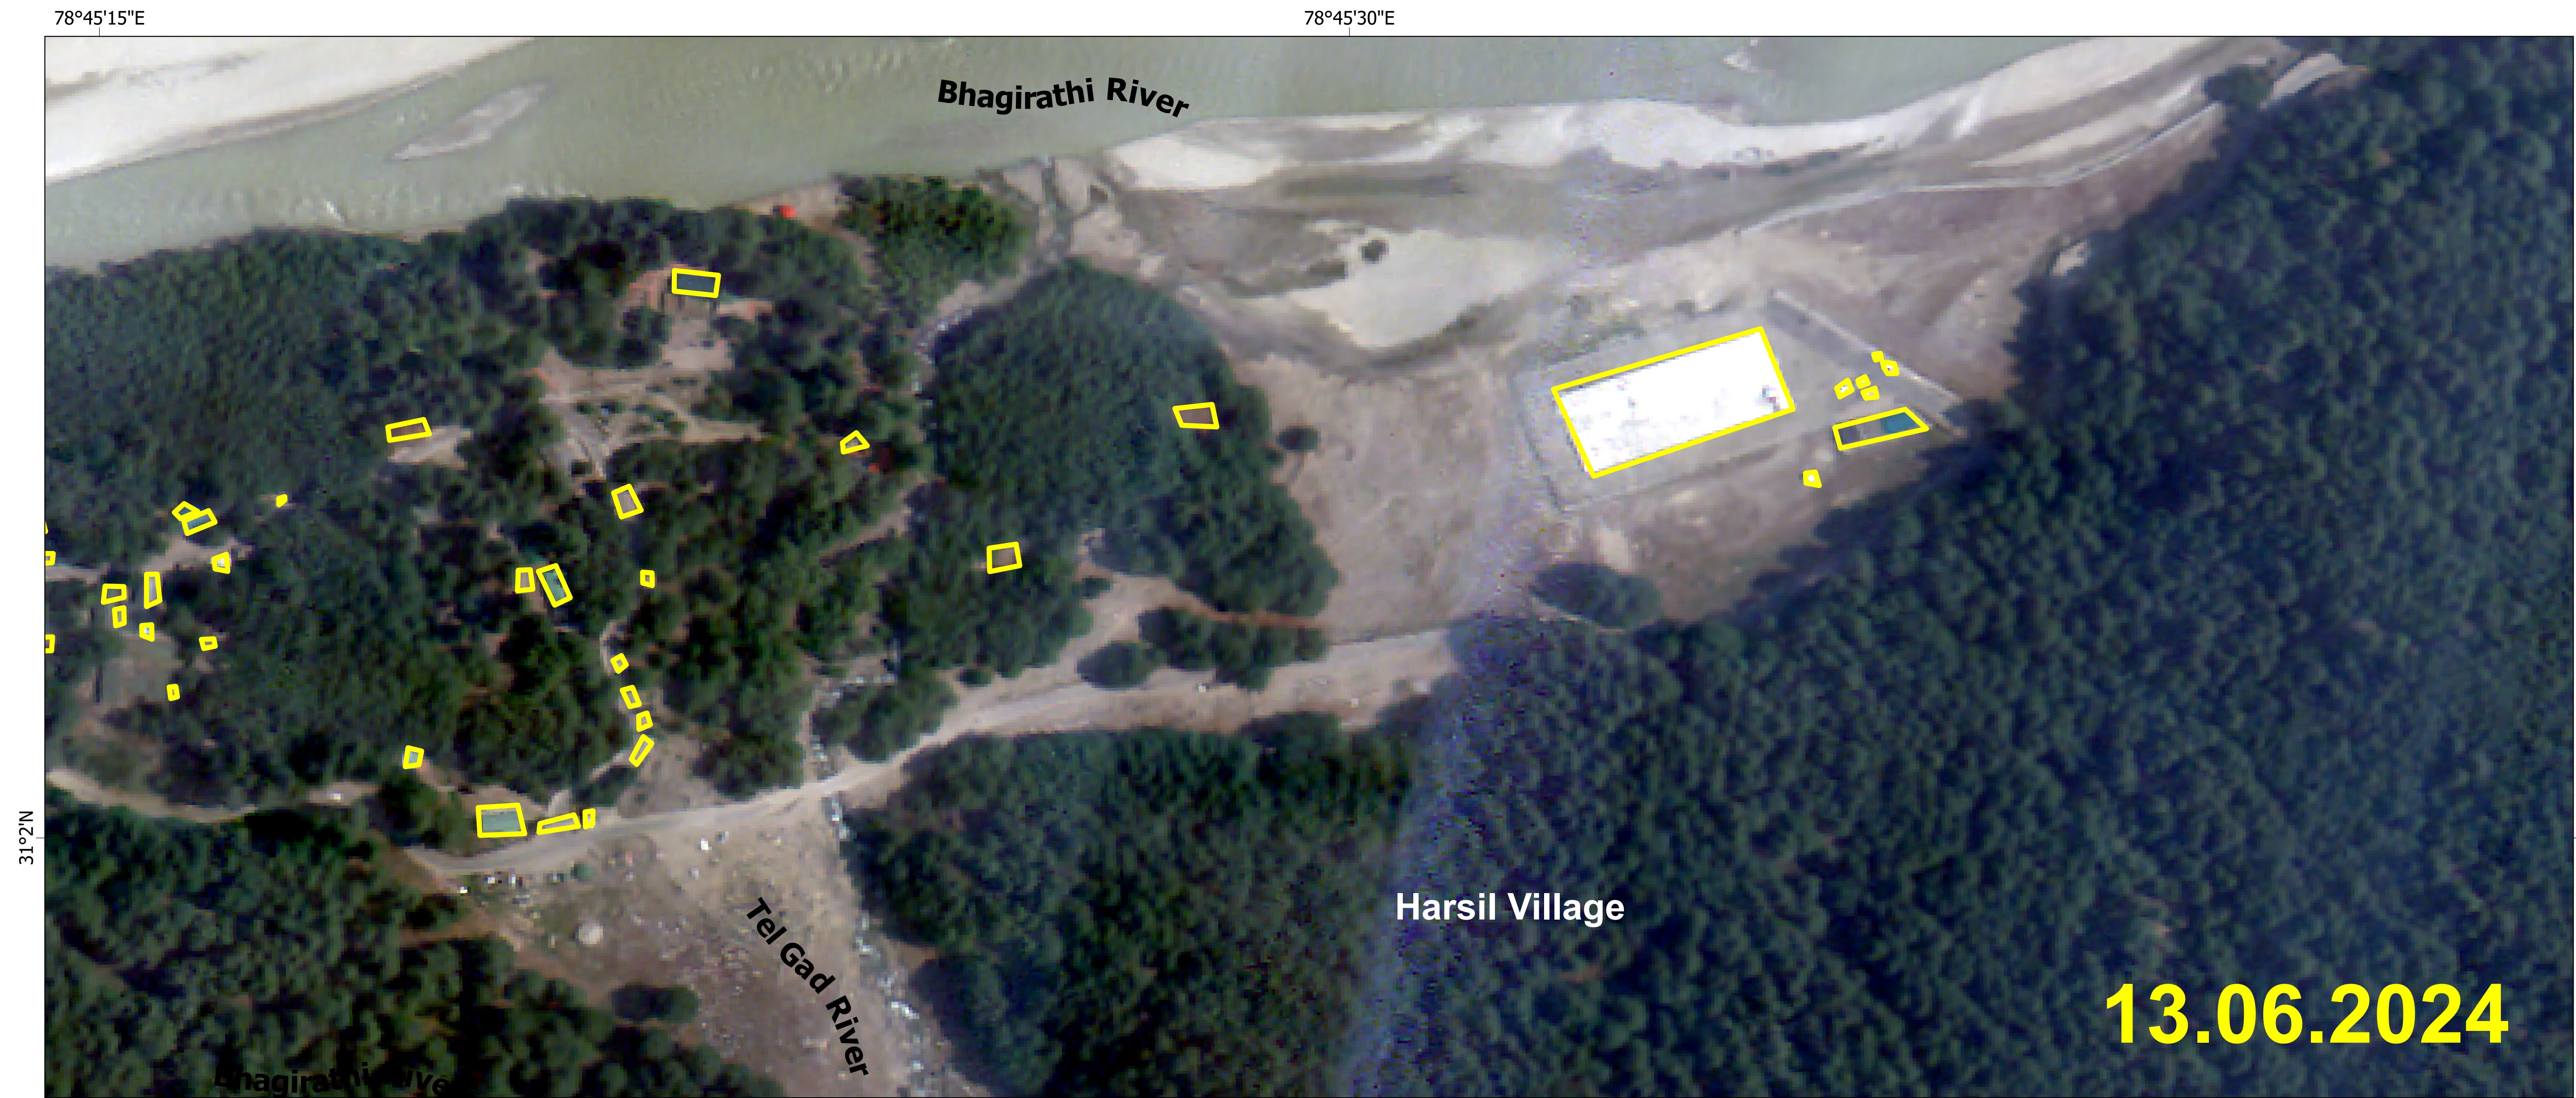
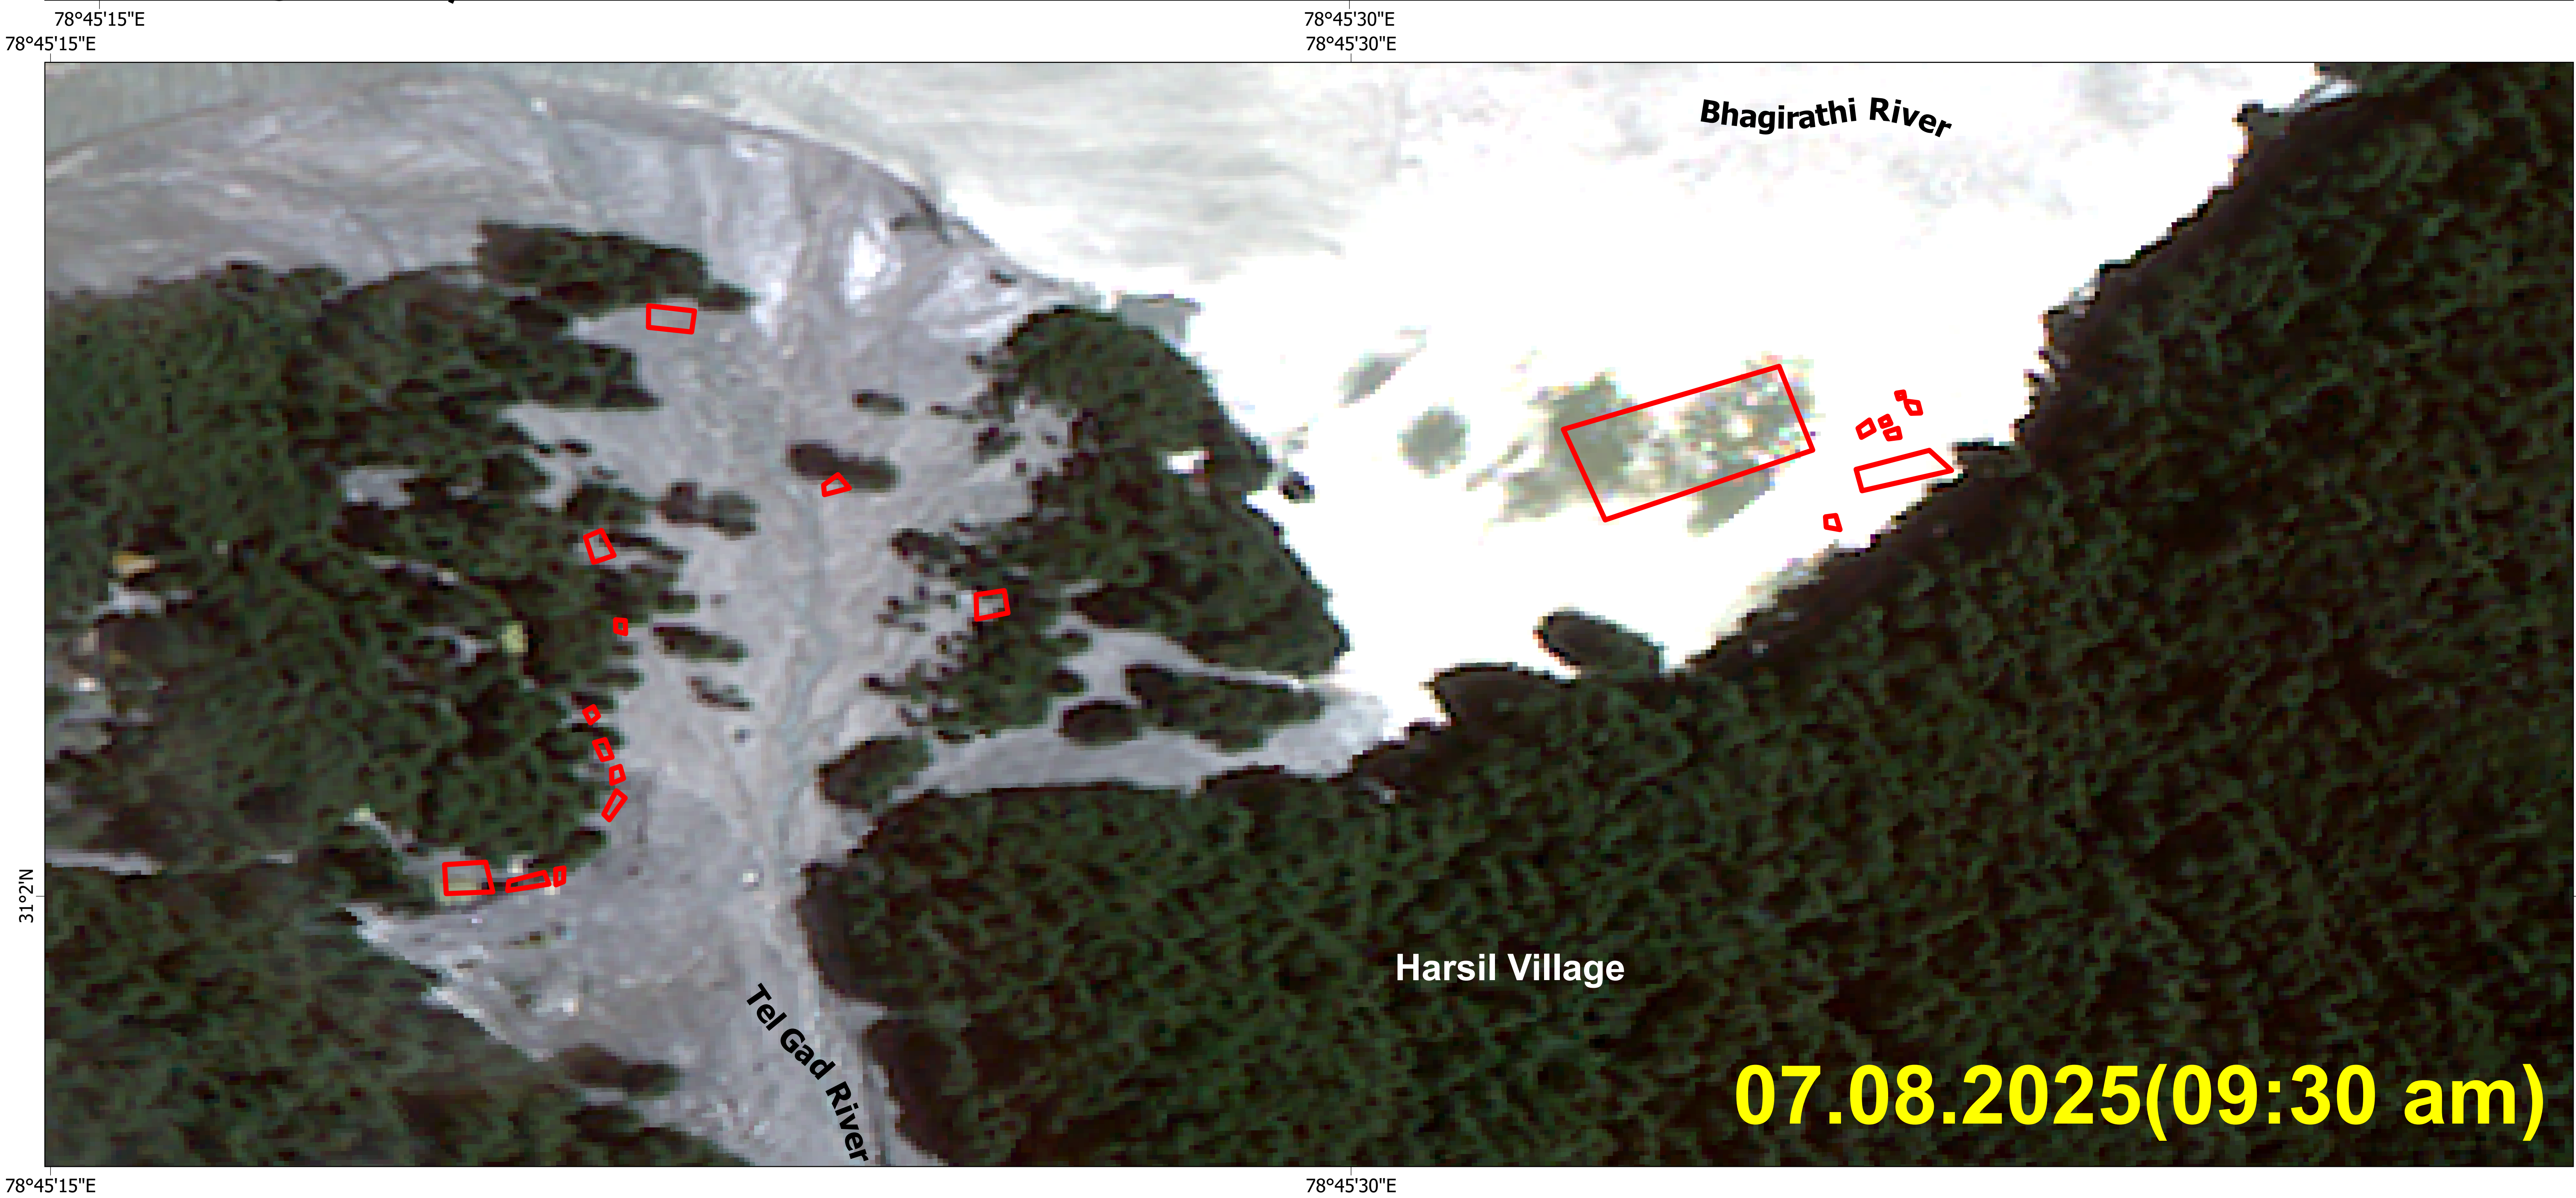
Satellite image acquired on 7th August, 2025 after the flood event. The impact is seen in Harsil village and surroundings depicting the disappearance of buildings, roads, plantations. Buildings Affected by flood are highlighted.
