Pre-Post Satellite Images - Harsil Village, Uttarkashi District, Uttarakhand, India.

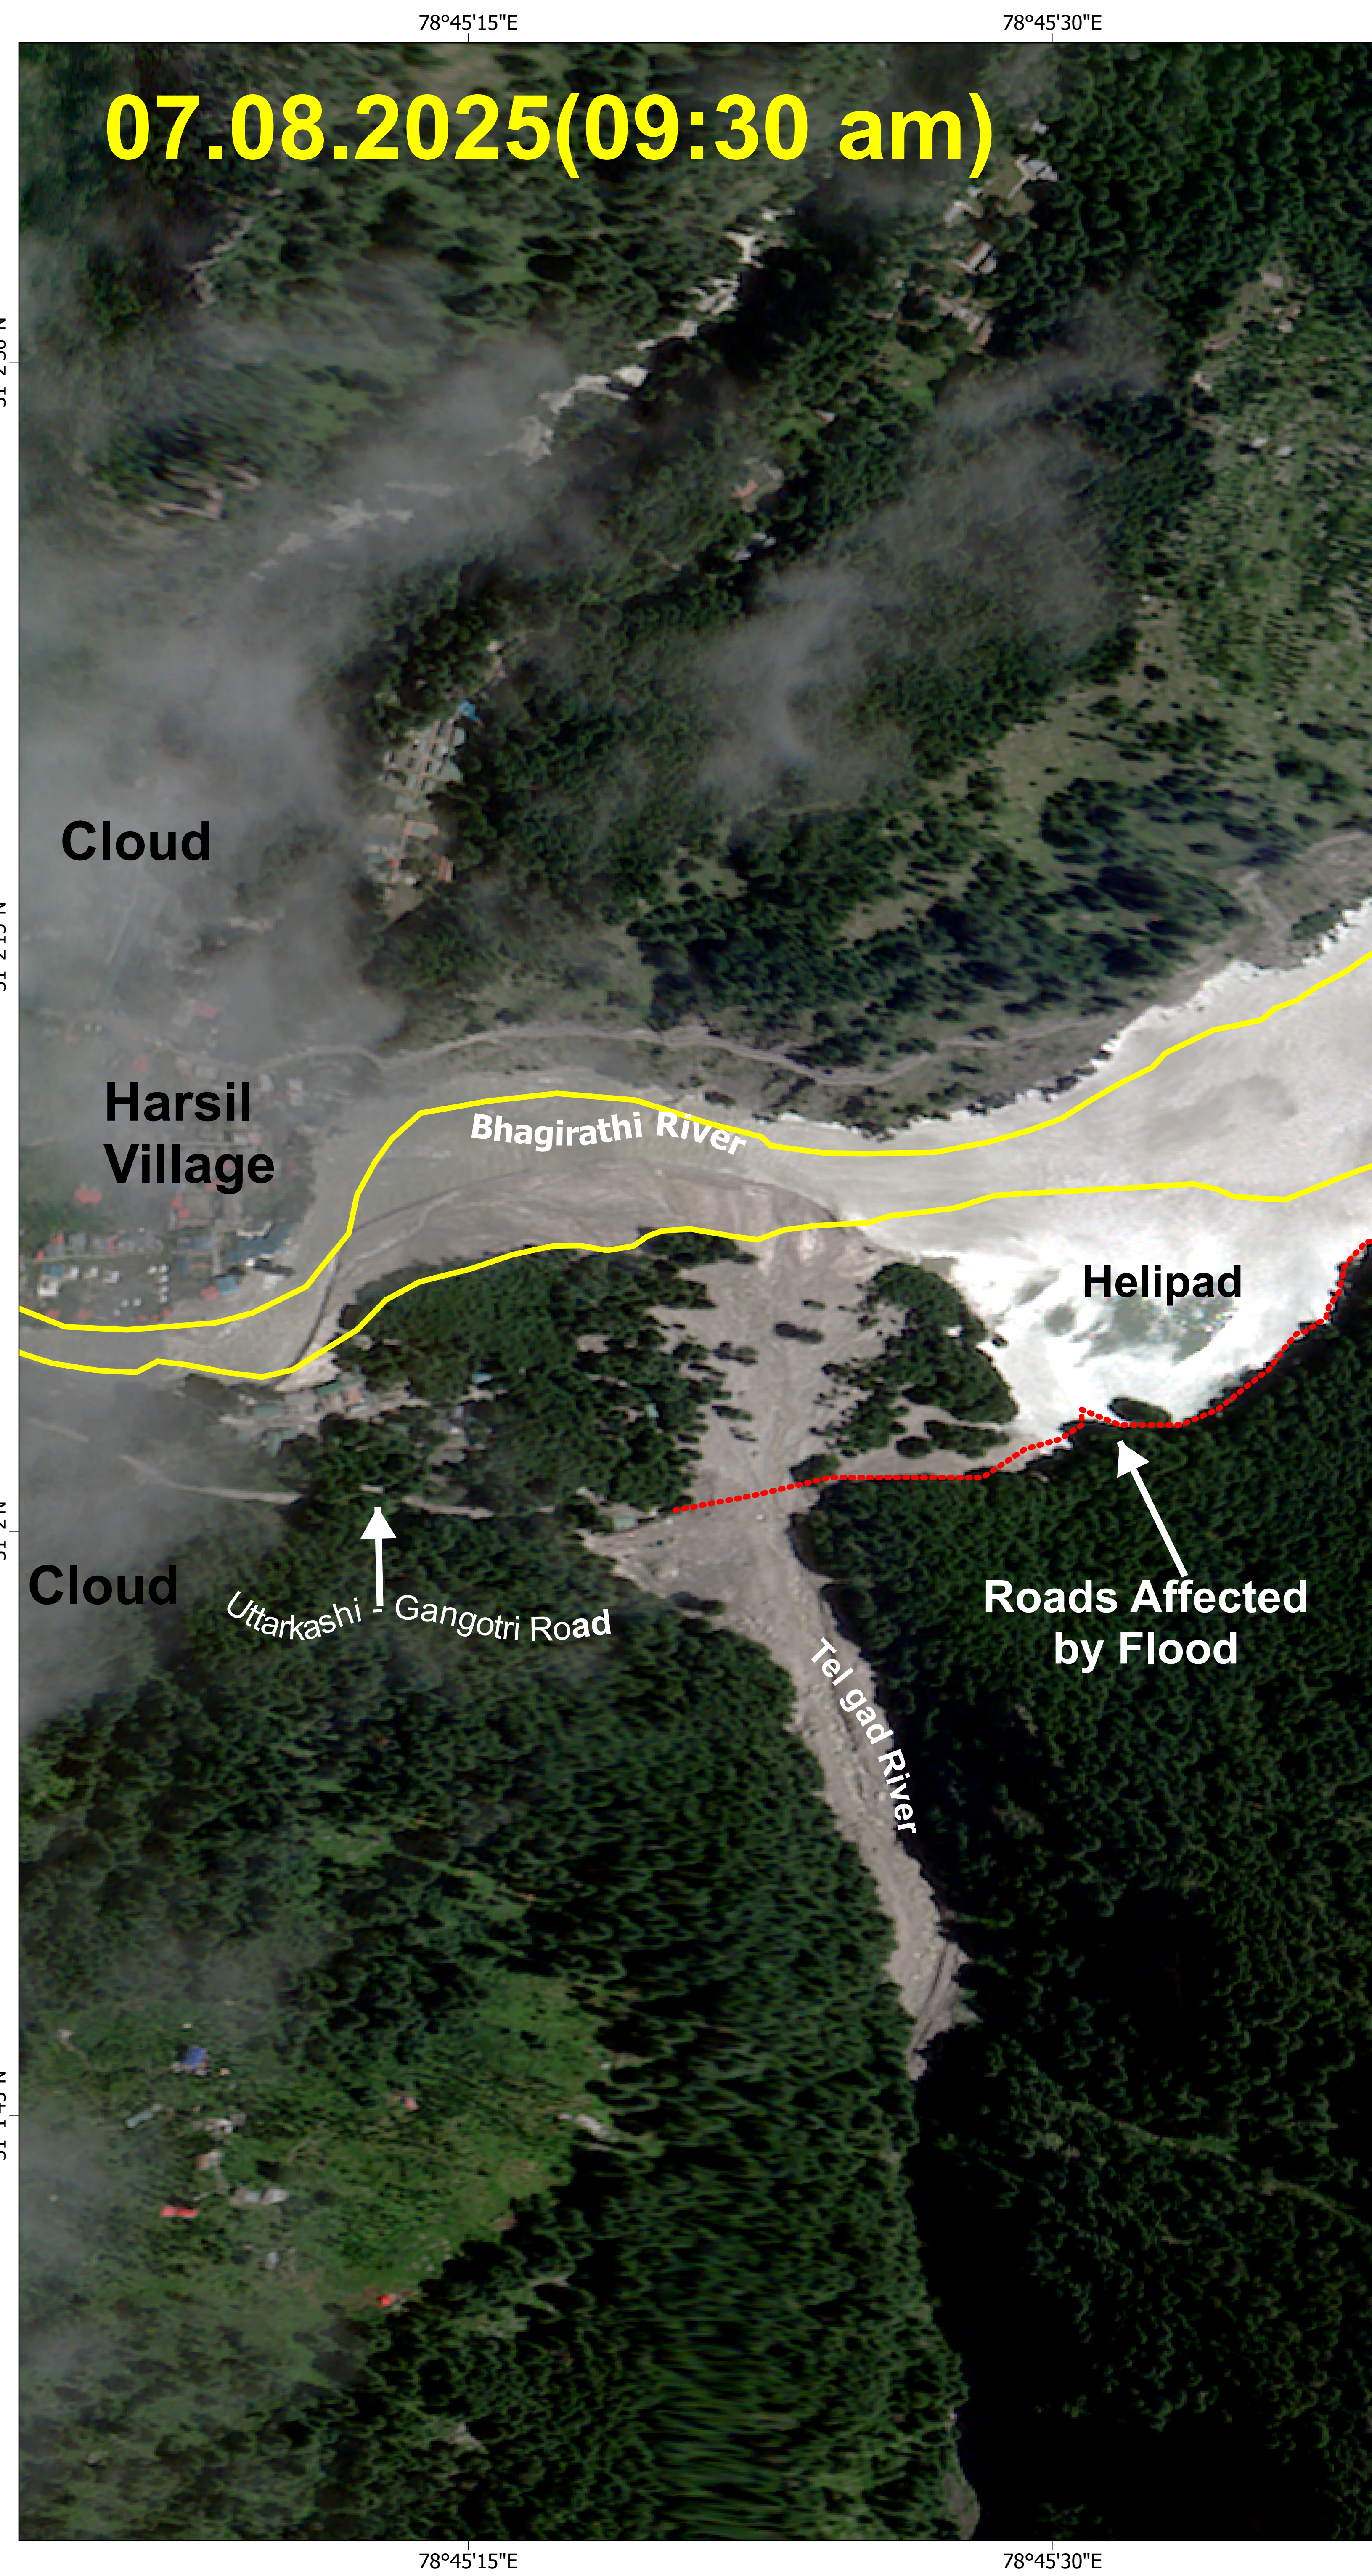
Satellite image acquired on 7th August, 2025 after the flood event. The impact is seen in Harsil village and surroundings depicting the damage to buildings, roads, and plantations. The roads affected by floods are highlighted.

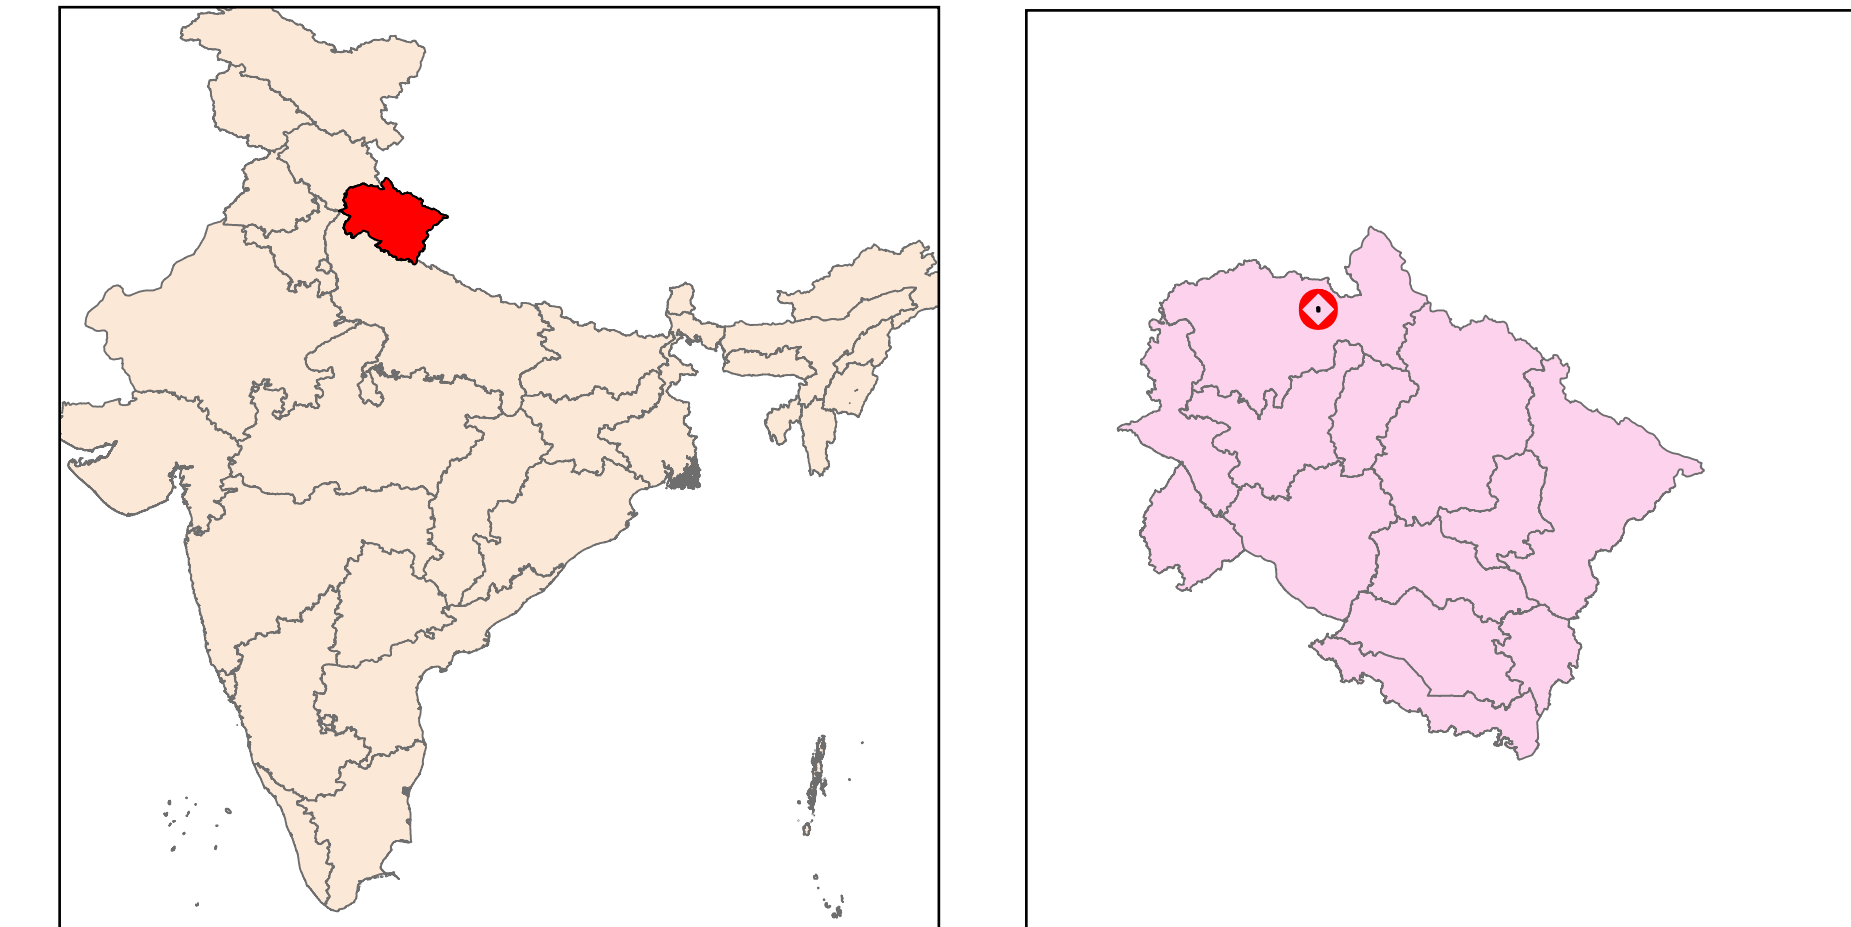
Pre Event Image : Cartosat-3, 13th June 2024
Post Event : Cartosat, 07th August 2025
