Damage Assessment in Dharali, Uttarkashi

Impact of Cloud-Burst

Observed on 06/08/2025

AOI No. 01

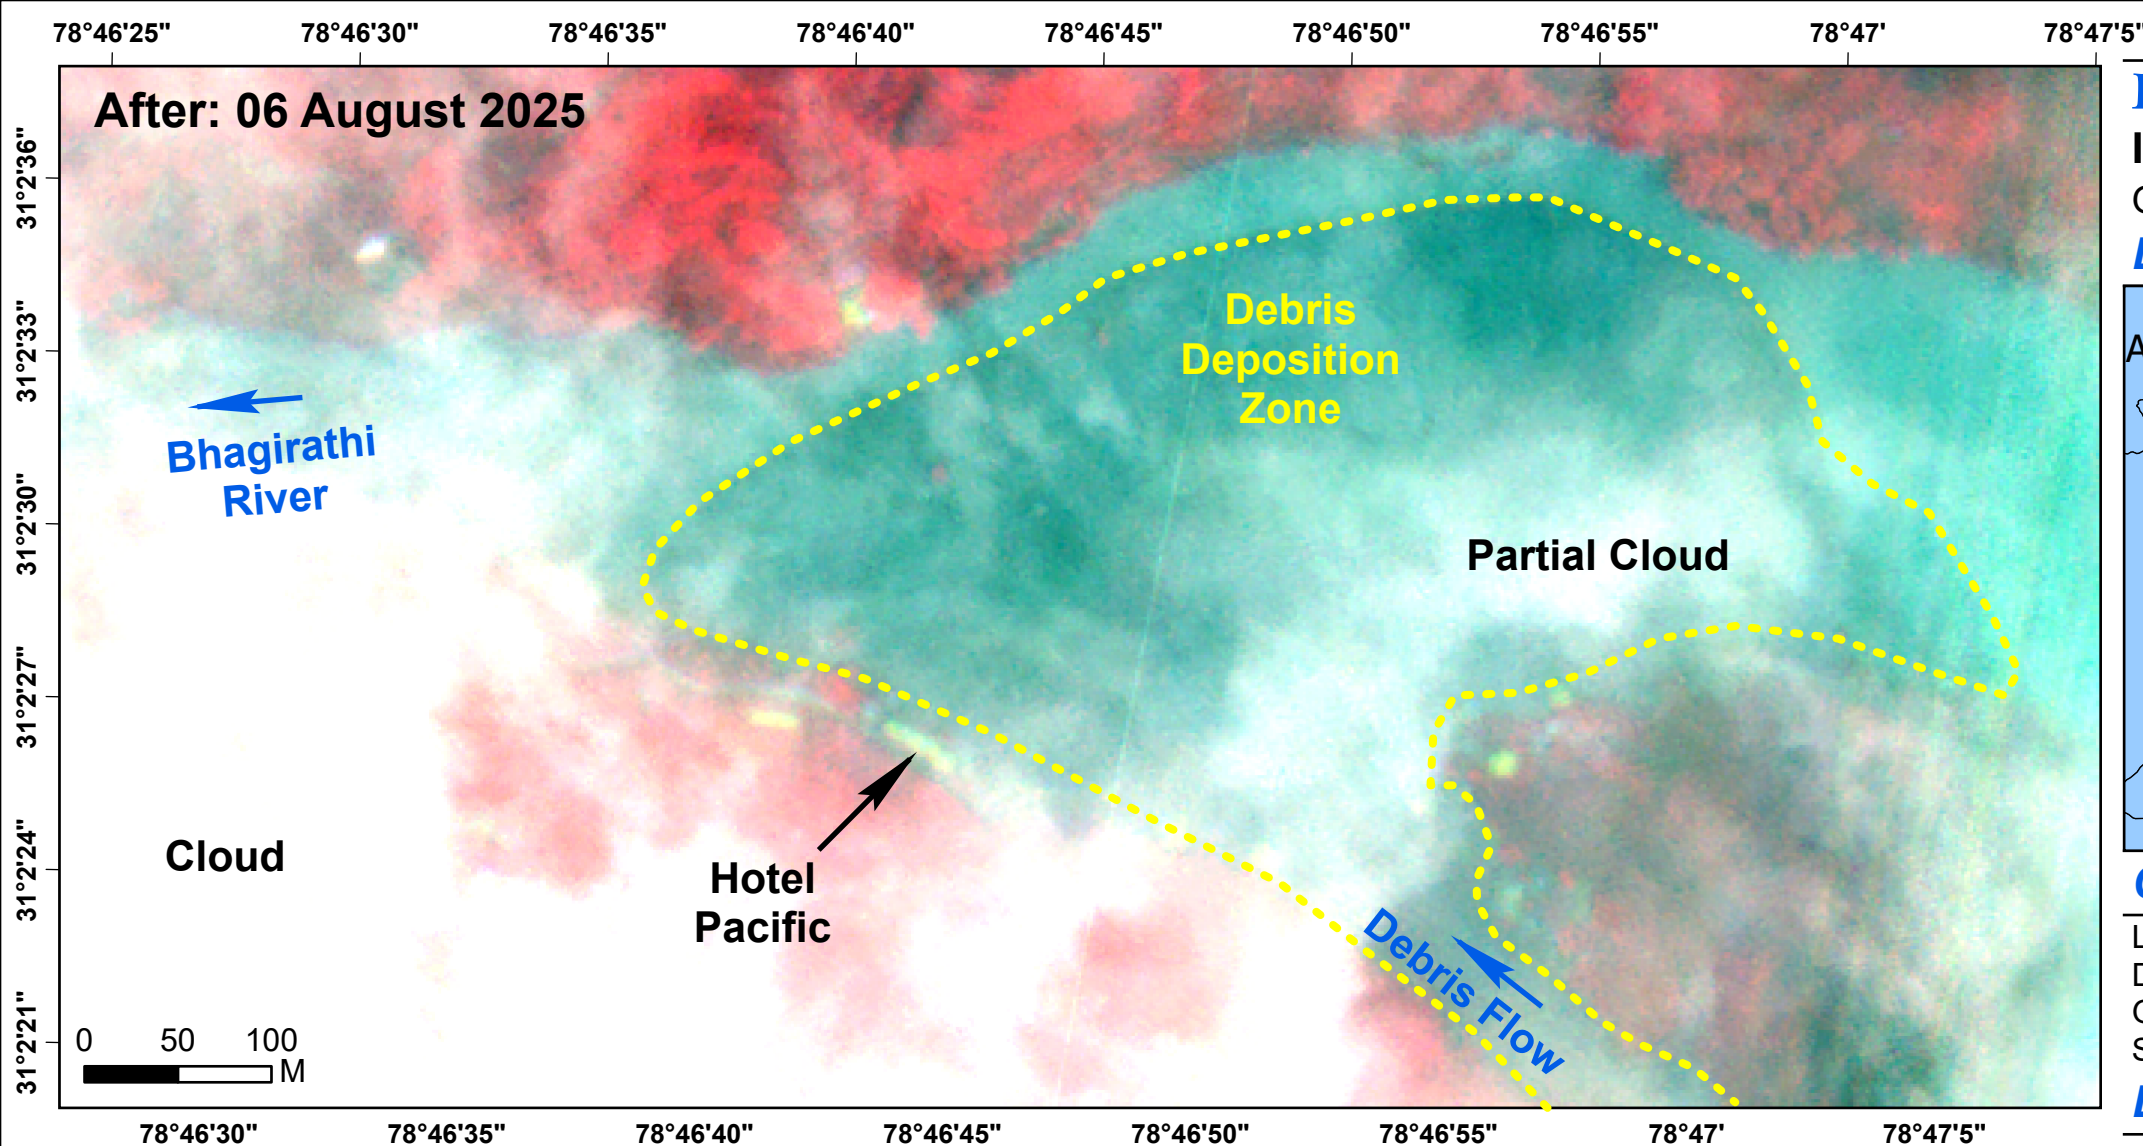
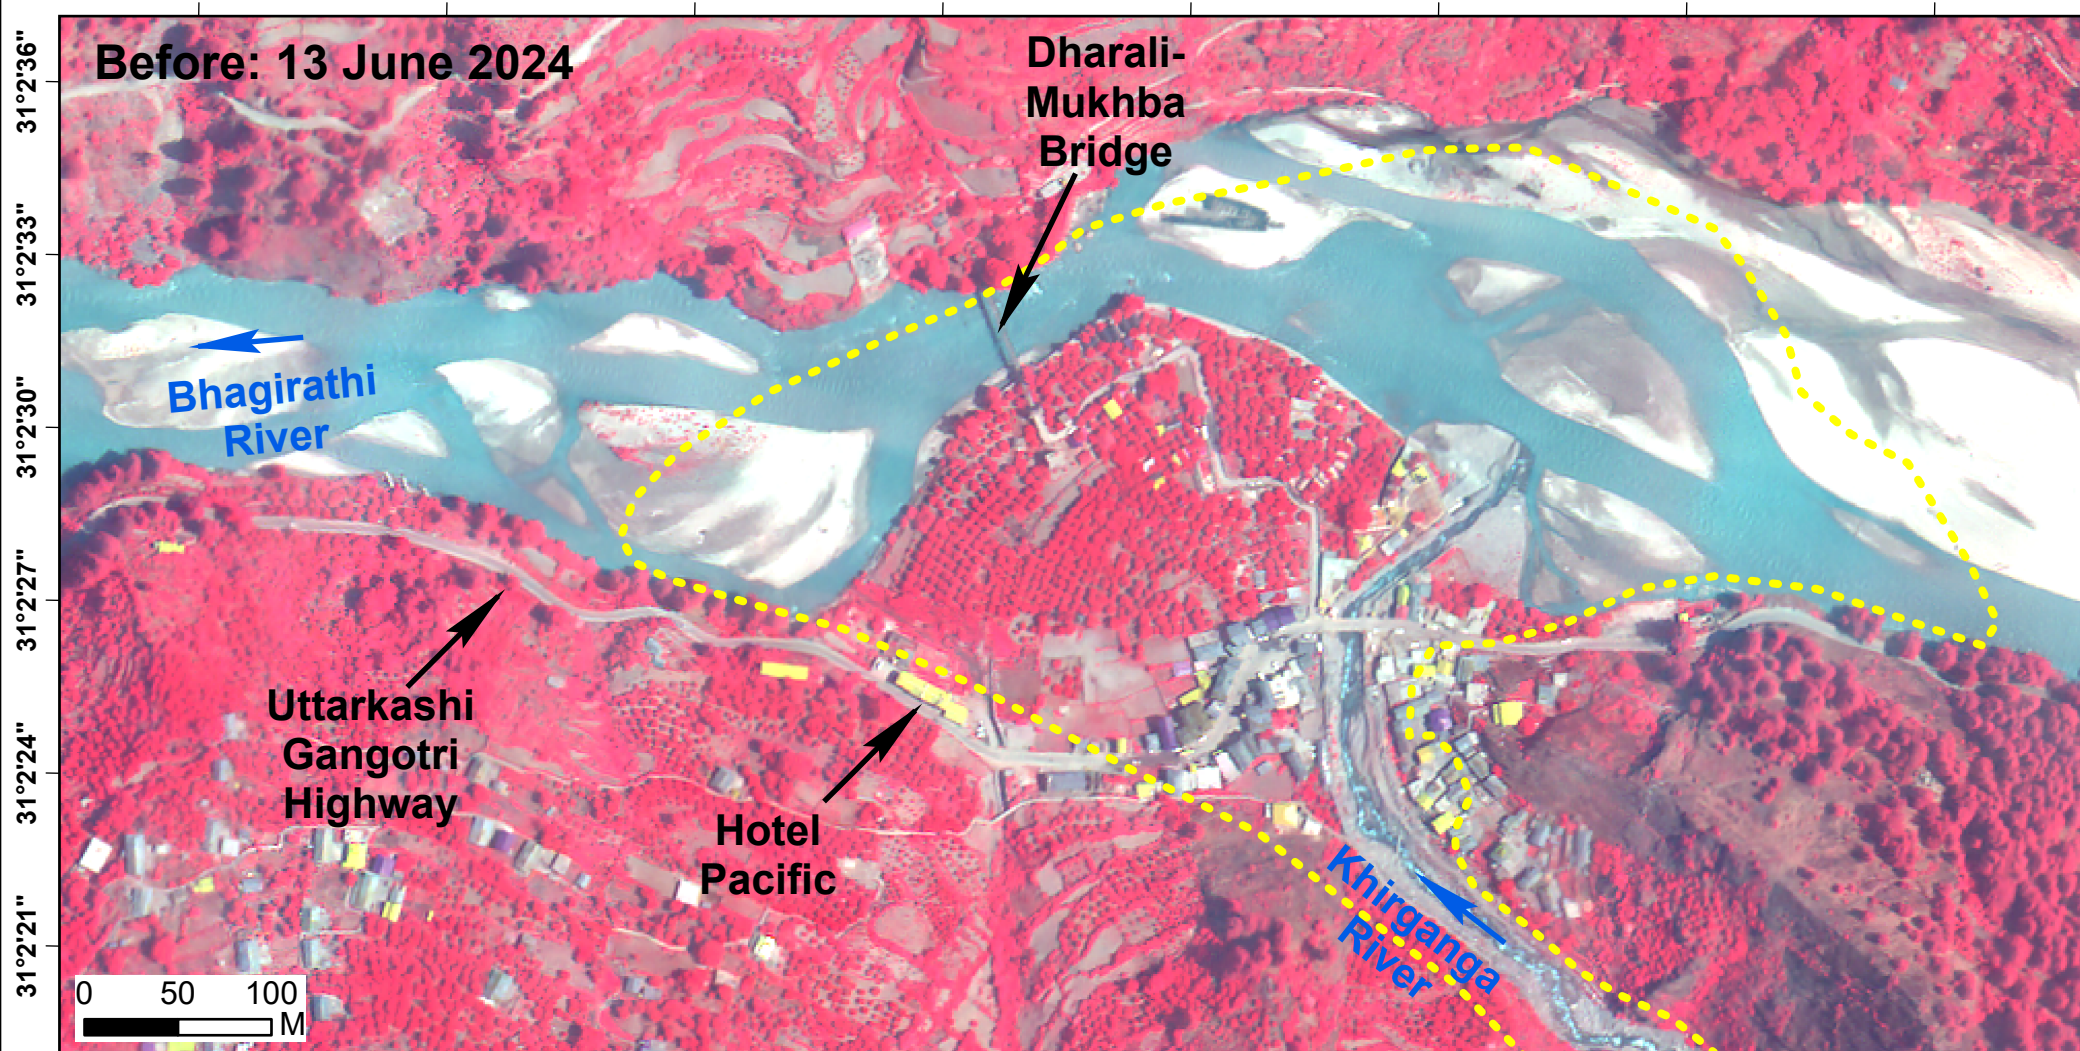
Dharali village was washed away by a devastating flash flood on 05 August 2025. The village is located along the route to Gangotri. In this event, several casualties have been reported along with extensive damage to infrastructure.

Satellite data collected from Cartosat-3 (before) and Cartosat-2S (after) of the event highlight the extent of the damage, debris deposition zone and partial blockage of the Bhagirathi River.
