# RISAT-1A FRS Satellite images showing Flood Inundation in Parts of Kaziranga National Park Assam State

2024/FL/AS/VAP/25/05072024

**Date of Issue:** 06.07.2024

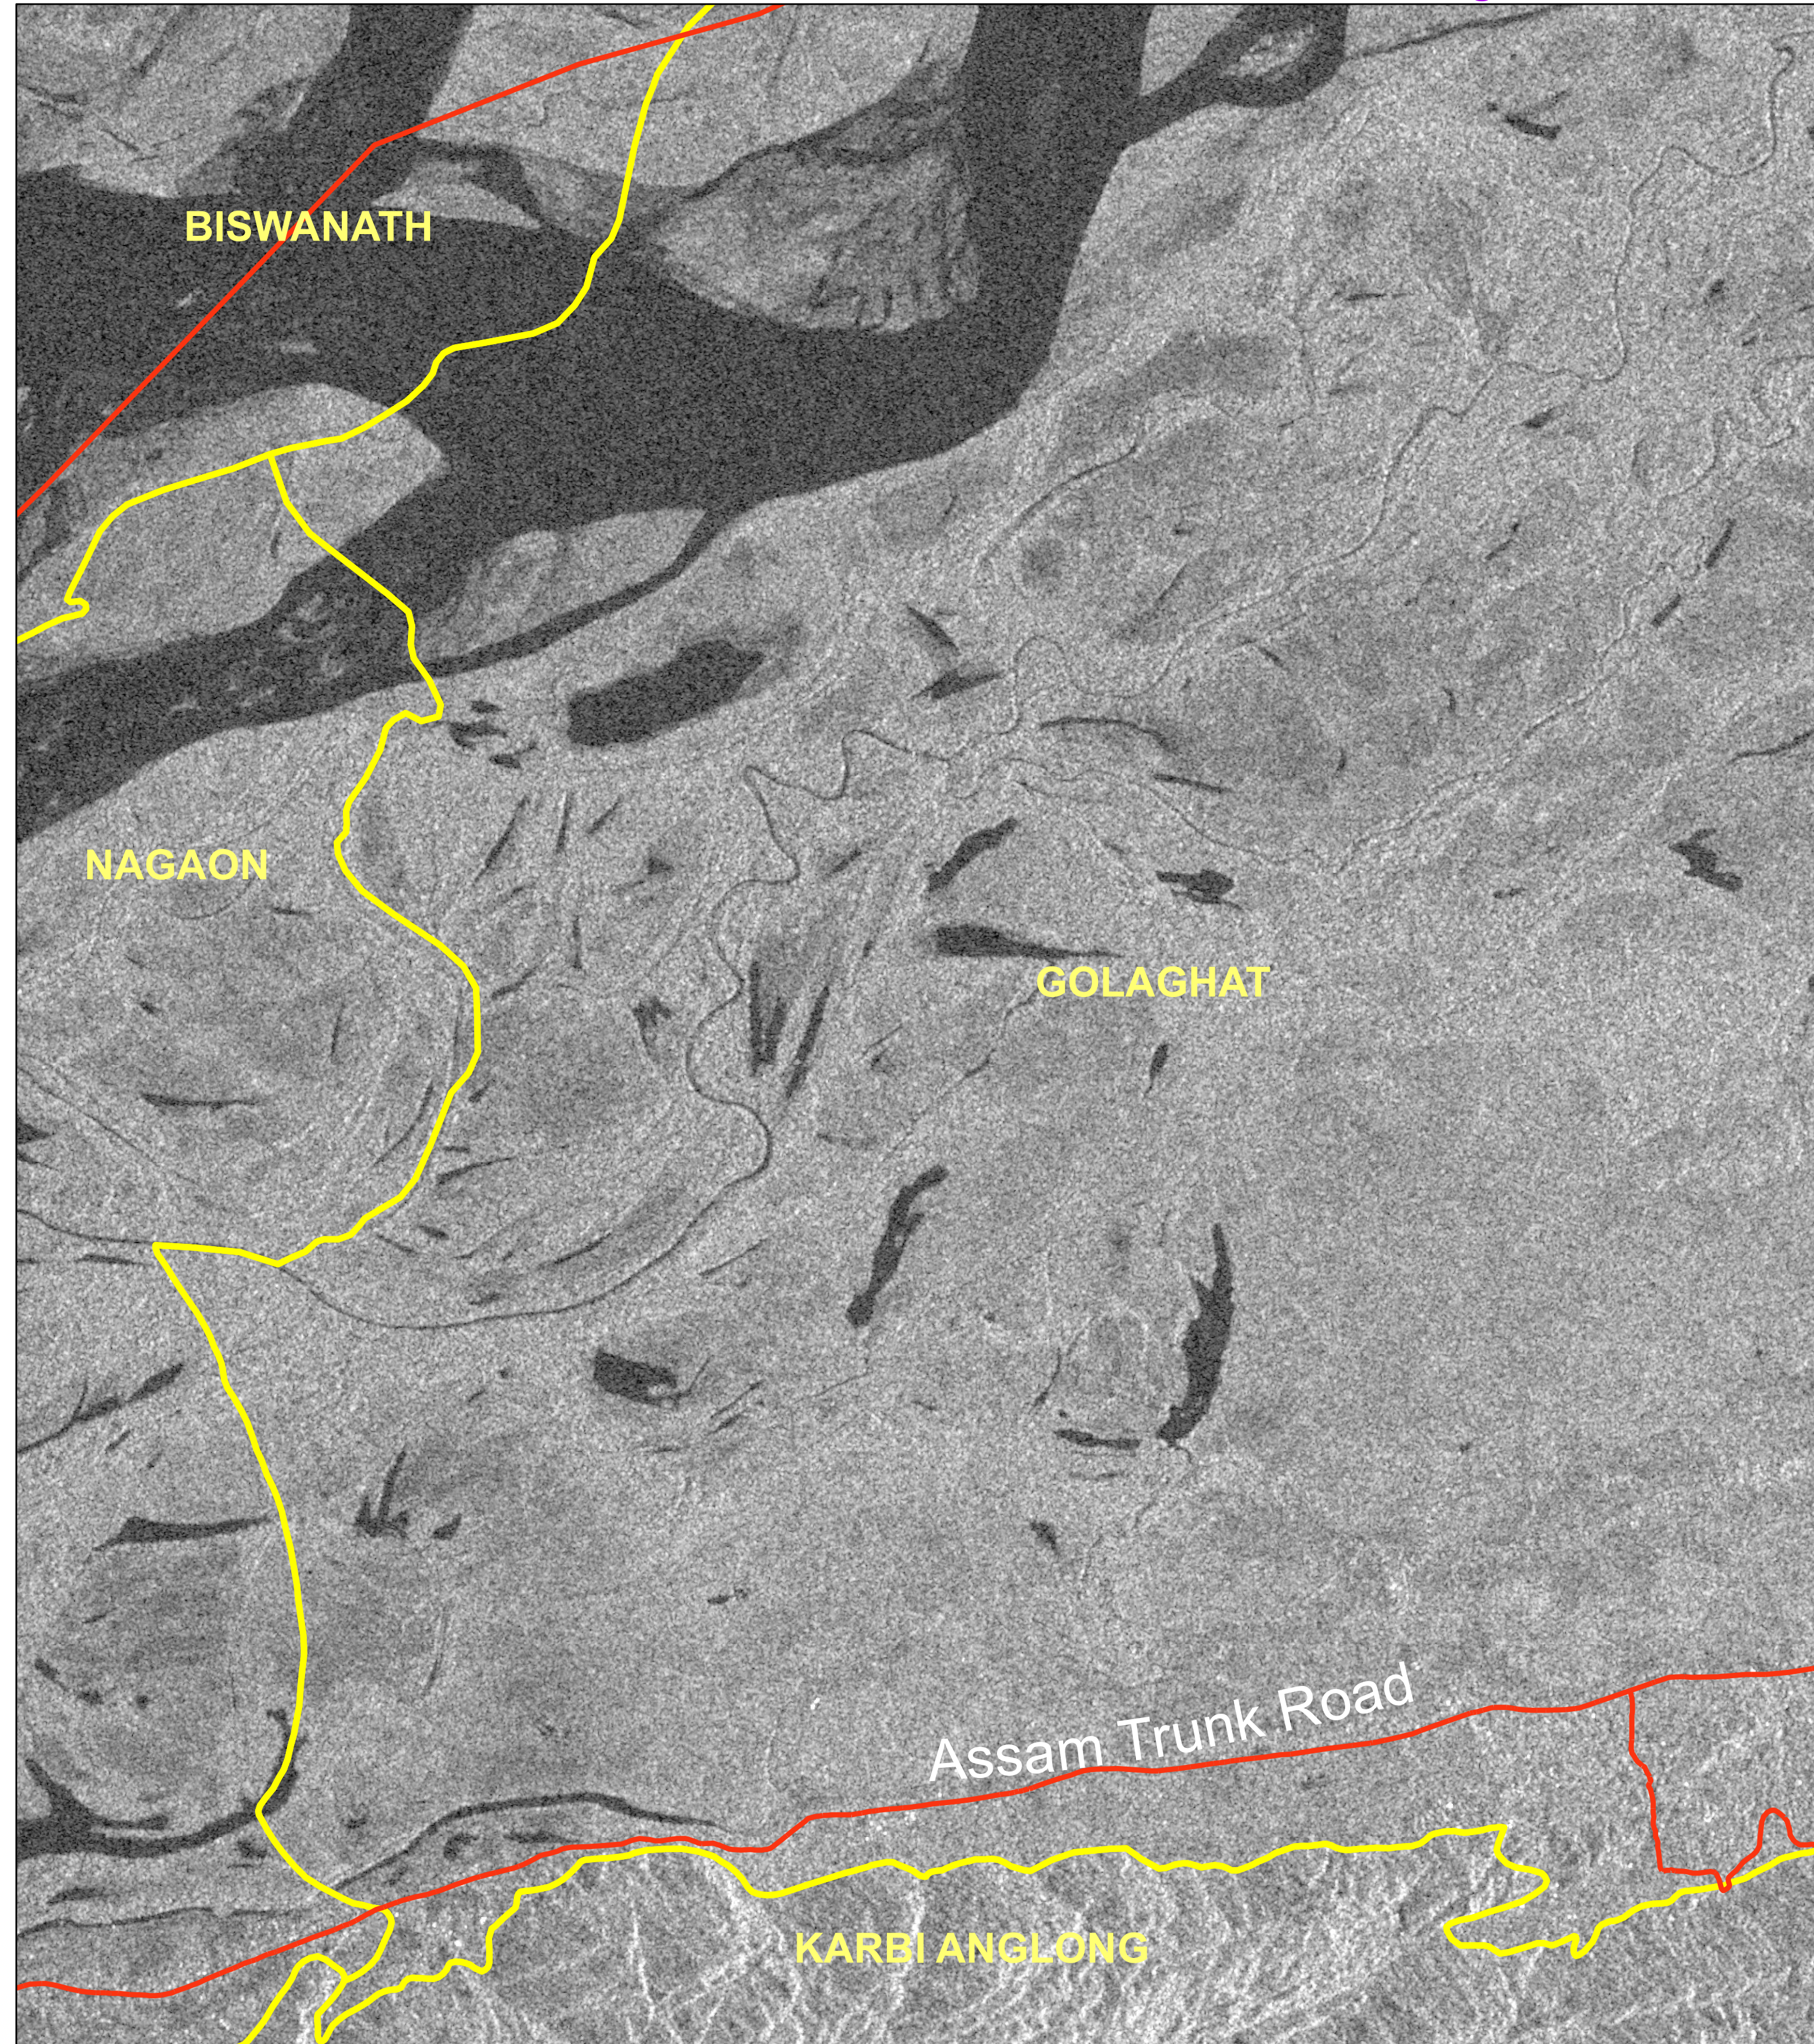
Pre Event

Sentinel-1A image of 14-05-2024

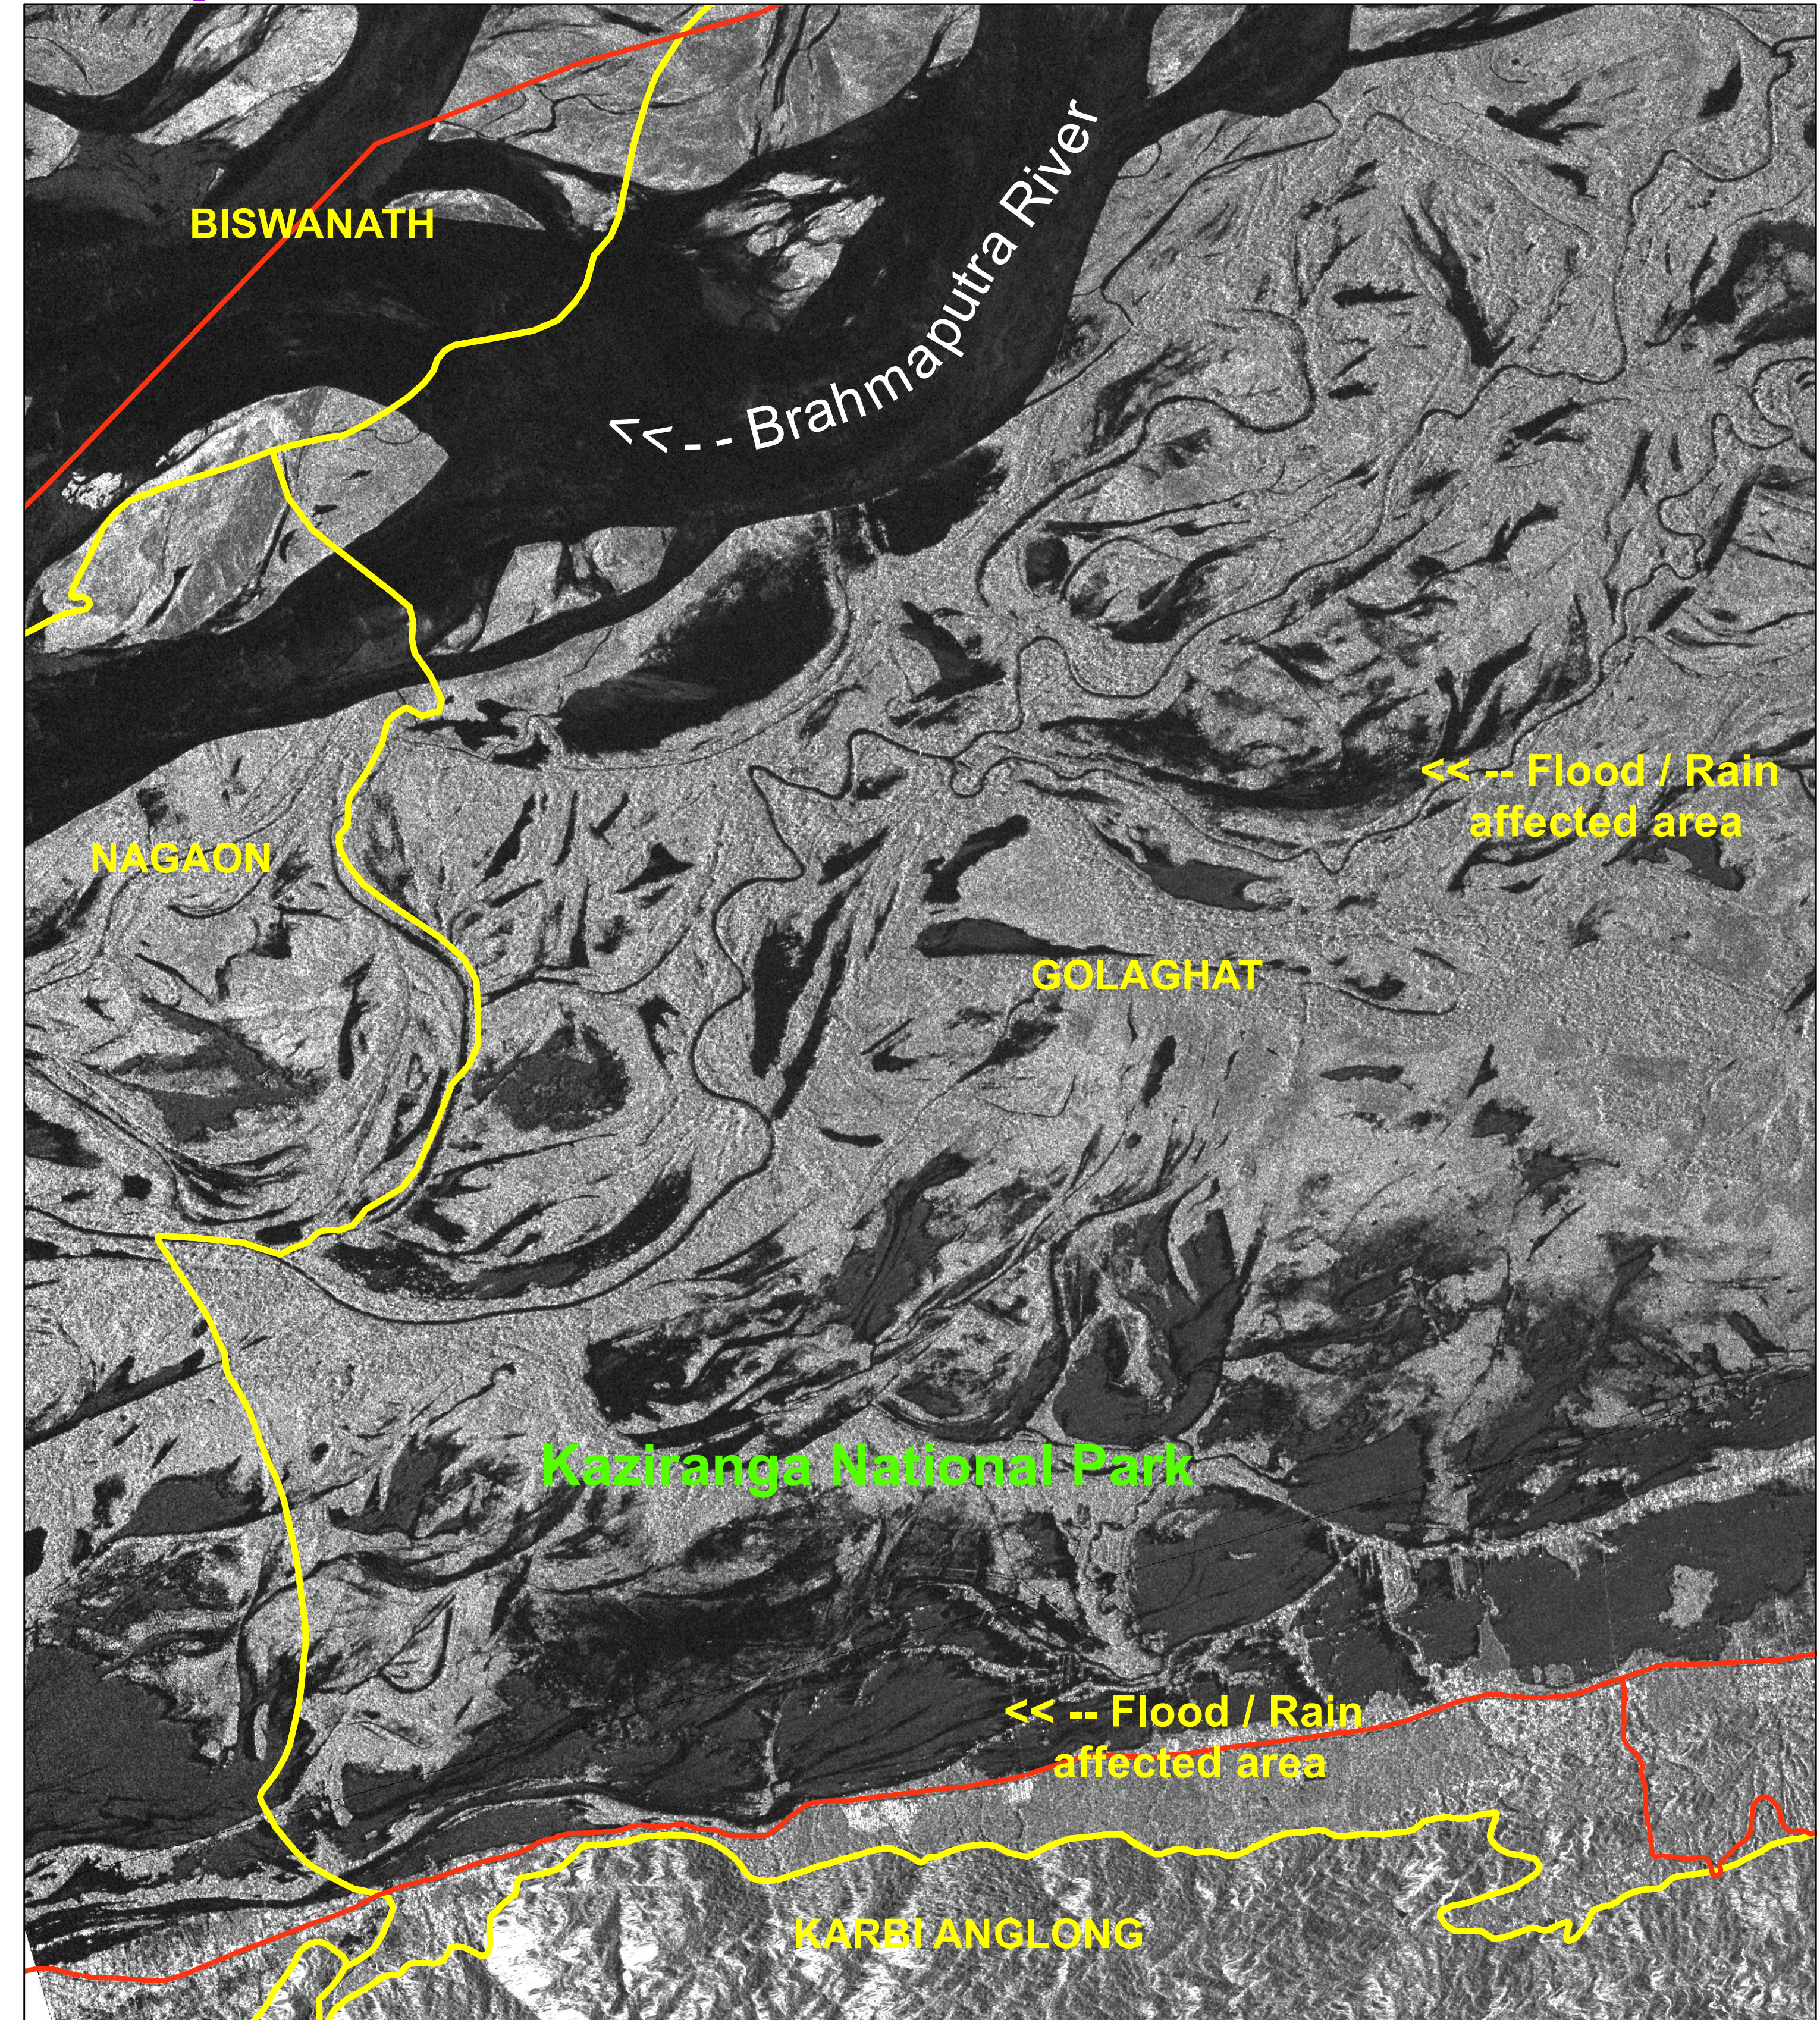
During Event

RISAT-1A FRS image of 05-07-2024
